## Baghouse

**Unit/Project/Equipment:** Applied to Baghouse from Cogeneration Unit at Riceland Foods

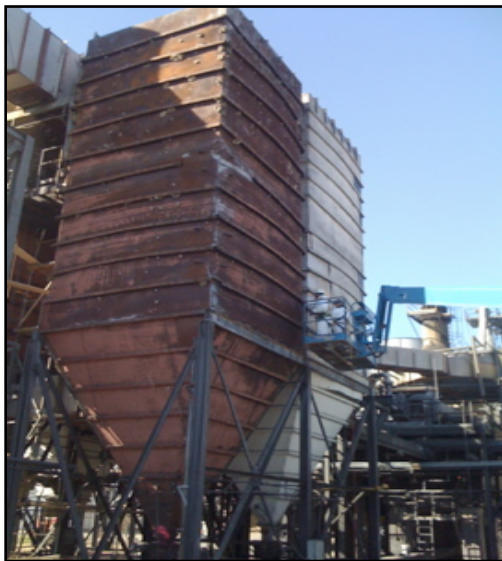
**Figure 2: Before Application**

**Starting Temperatures:** Temperatures range from the Inlet 320°F (160°C) to outlet Temperature 170°F (76°C)

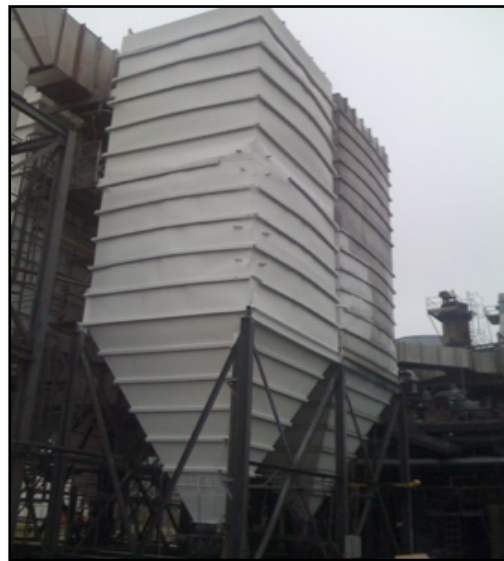
**Figure 1: After Application of Mascoat Industrial-DTI**

**Post application results:** Temperatures ranged from 100°F (38°C) to 130°F (54°C)

**Product Used and Millage:** Mascoat Industrial-DTI 80 to 100 mils (2-2.5 mm)
