## Cargill – Reduce Fire Risk

**Company:** Cargill Foods

**Application:** Cocoa bean crusher

**Material:** Mascoat Industrial-DTI

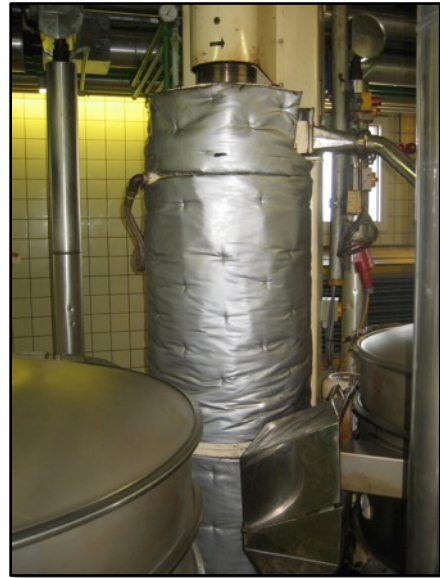
Excess cocoa fat and grease would seep out of the crusher and into the insulation lining the sides. Not only did this drastically reduce the effectiveness of the insulation, it was also extremely flammable, making the area unsafe. After learning about Mascoat Industrial-DTI on the Internet, the company contacted Mascoat to see if the coating would be a viable substitute for the traditional insulation causing them so many issues.

**Traditional insulation that became flammable after absorbing grease.**

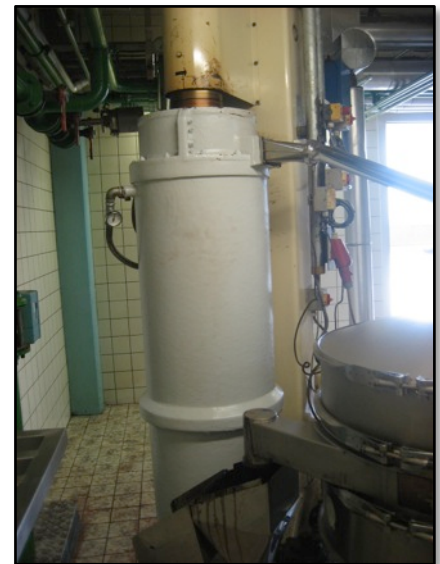
**Crusher after being coated with non-flammable DTI**

DTI has been applied in food and beverage facilities around the world. The non-flammable coating is not affected by moisture, leaks, or grease, so the Mascoat representative knew immediately that the coating would solve their issues. After an initial test, the company applied 140 mils (3.5 mm) of the coating to the crusher. Even though DTI is food-safe approved in countries around the world, including the USA, Cargill applied an anti-bacterial topcoat. The system now dependably allows for personnel protection, energy retention, ease of cleaning, and a better working environment.
