Tepsa Storage Tank – Energy Retention

Company name: Tepsa

Location: Bilbao, Spain

Coating: Mascoat Industrial-DTI

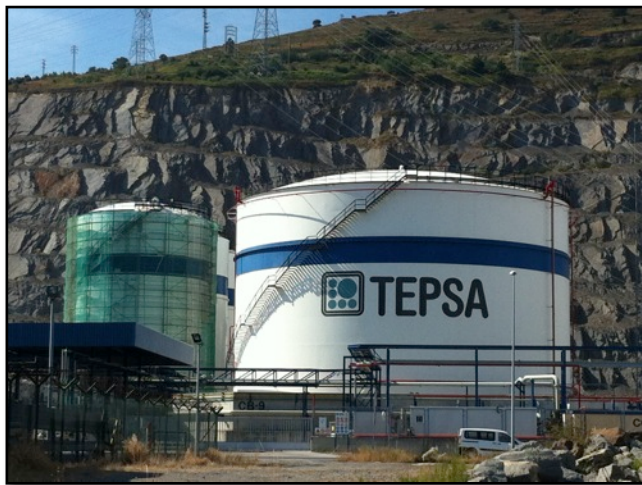
To keep the contents around a constant 104°F (40°C), Mascoat recommended to apply 60 mils (1.5 mm) of DTI to the roof and outer walls. Unlike conventional insulation, DTI will stand up to foot traffic on the roof. Most conventional insulation will degrade and fall apart quickly after repeated foot traffic, which is why most storage tank roofs remain without insulation.
