Technical Report – CHILLED WATER TANK

Subject: Chilled Water Tank at Calpine Cogeneration Plant

Date: September 2009

Problems: Insulation destroyed by hurricane force winds, Corrosion Under Insulation (CUI), and radiant heat gain

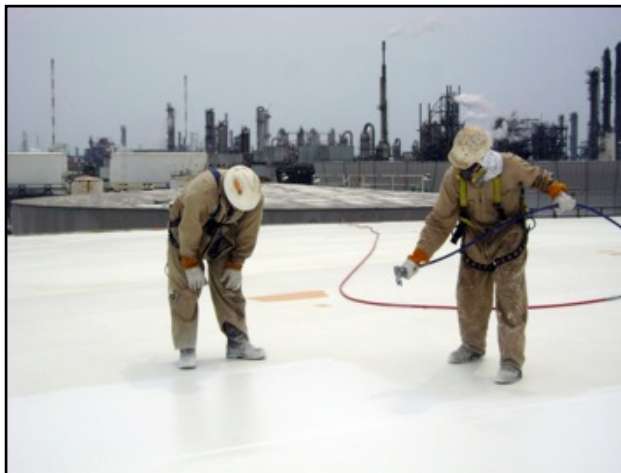
Calpine's Cogeneration Plant, located in Pasadena, TX USA needed to replace 1.5" of foam insulation on a 120 foot OD Chilled Water Tank that was damaged during Hurricane Ike in September 2008. When the damaged insulation was removed, the substrate was already beginning to corrode. While researching options through approved contractors, Brand Industrial informed Calpine about Mascoat Industrial-DTI from the success they had seen at other facilities. Between ease of

application, the coating's ability to withstand weather and the fact that it would provide an excellent radiant barrier, Calpine decided to apply the coating to the tank top.

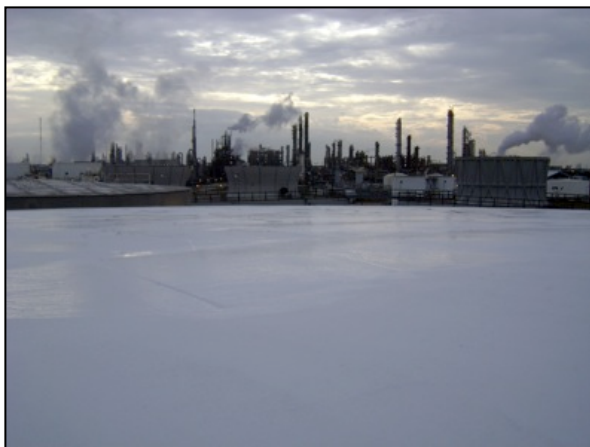
After the substrate was sandblasted and primed with Amerlock 400, 40 mils of Mascoat Industrial-DTI was applied in two successive coats by a crew of 4 men. A total of 5 days was needed to coat the entire roof of the tank.
