## Condensate Tank – Chemical Plant

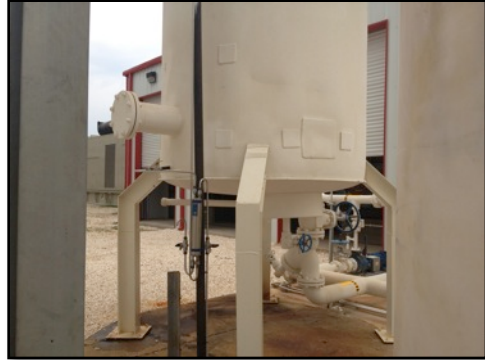
The surface of a condensate tank in South Texas was consistently around 190°F (87°C), well above personnel protection limits. To protect the crew's safety, the plant originally tried traditional insulation; however, water often spilled out of the top of the tank while it was in service. The water would saturate the traditional insulation, dramatically reducing its effectiveness and causing corrosion under insulation (CUI).

**Surface Temperature of Uncoated Area** – 180°F

**Surface Temperature of Coated Area** – 133°F

**Ambient Temperature:** 79°F

**Coating Dry Film Thickness** - 100-120 mils

**Coating Adhesion** – Good

**Chalking or Other Coating Deterioration** – None

To help find a solution, the plant's head engineer contacted Mascoat. Mascoat's unique thermal analysis program was able to recommend a custom plan specific to resolving the plant's problems. After applying 100-120 mils of Mascoat Industrial-DTI, the plant was able to provide personnel protection required by governing standards and increase the tank's energy retention.
