Geothermal Plant Electrical Boxes

Coating used: Mascoat Industrial-DTI

Reason for coating: Circuits overloading, labor, and shutdown costs

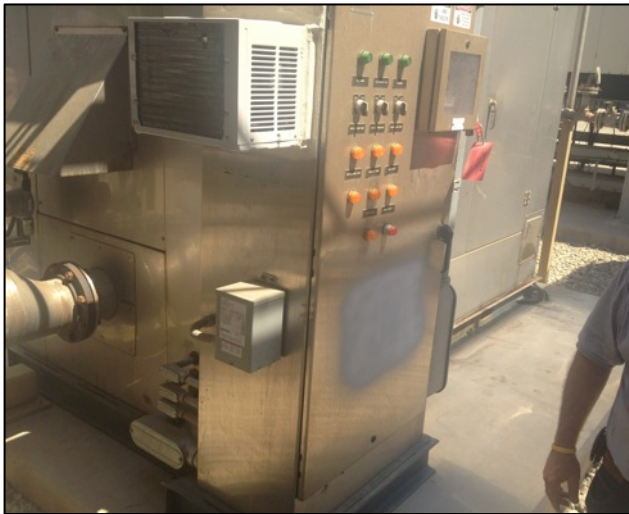
A geothermal plant in the desert was having trouble with the circuits in their electrical boxes. During the day, the sun was heating the stainless steel boxes to over 155°F (68.3°C), which was causing some of the internal circuits to overload. The cost of these unexpected shutdowns was two fold. No only did they have the cost of parts and labor to do the repairs, but they also had to shutdown the processes the boxes were controlling.

These boxes were going to be very difficult to insulate traditionally due to

the numerous switches on the outside. There was also no room for insulation on the inside, so the plant decided to try an insulation coating to reduce the internal temperature.

The application procedures for this project were very straightforward. No primer was required because the substrate was stainless steel, and the prep work consisted only of a light solvent wipe. The plant then had two of their in-house painters apply 2 coats of Mascoat Industrial-DTI White using Mascoat's Small Application Sprayer, which only requires an 80-psi air source. Two of these boxes were coated in one morning of work.

At the end of the summer of 2013, Mascoat followed up with the customer to see how the application was performing. The customer said, "We are thrilled with the results. We haven't had to replace any of the circuits in those boxes since we coated them. For a few hundred bucks we were able to solve a problem the was costing us thousands each summer."
