## Geothermal Plant End Bell

**Coating used:** Mascoat Industrial-DTI

**Reason for coating:** Insulation on end bells of heat exchangers

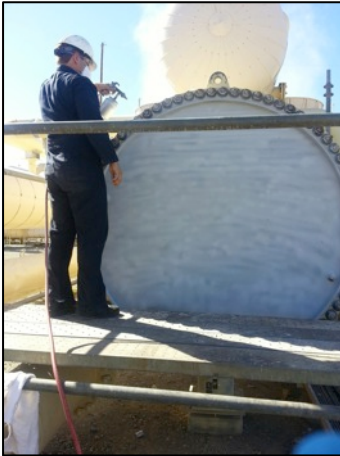
A geothermal plant in Southern California was having problems with the insulation on the end bells of their heat exchangers. They had to remove the end bells 2-4 times a year for maintenance on the internal tubes. Since they weighed approximately 9,000 pound, whenever they removed them and laid them on the ground, the insulation would be crushed. They, therefore, had to remove the insulation every time they remove the end bells. This was a very costly procedure.

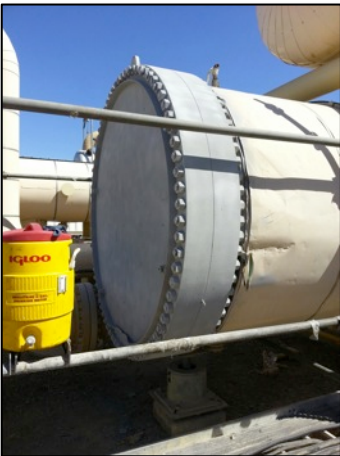
Mascoat offered their Industrial-DTI product as a solution to this problem. It was observed that there was a 3" steel lip running around the rim of the end bell. When it was laid on the ground, the whole weight of the end bell rested on this lip, which meant that the rest of the surface area would be undamaged if it was coated with an insulation coating. After the maintenance was complete, the lip could be quickly repaired with Mascoat's Small Application Sprayer. This would save the company about 7 hours of labor every time they had to remove the end bell and a significant reduction of material costs.

The company decided to insulate the end bell with 80 mils (2 mm) of DTI. Since DTI can be applied to hot surfaces, the application was done while the heat exchanger was in service at 200°F (93.3°C). The company was very happy with the results.
