## Juice Heater – MA Patout

**Company Name:** MA Patout

**Location:** Jeanerette, LA, USA

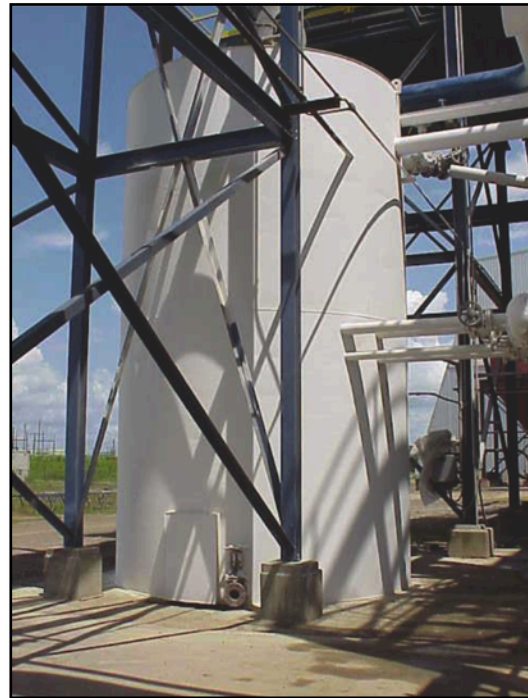
Since DTI is spray-applied directly to the substrate, there is no room for moisture to collect between the insulation and the substrate. This effectively stops Corrosion Under Insulation, protecting the new heater, while at the same time providing the insulation abilities needed to keep the refinery process on schedule. It seemed to Mr. LeBlanc that this would solve all of his problems.

A two-man crew coated the new heater with 80 to 100 mils (2.0 – 2.5 mm) of Mascoat Industrial-DTI over two days prior to the start of the next sugar season. After application, Mr. LeBlanc saw that the coating would also give him constant inspectability of the substrate at all times, thus easing more of their maintenance concerns. Once the juice heater was placed into service, Mr. LeBlanc reported that the insulating power of Mascoat Industrial-DTI was identical to the 2 inches of brand new fiberglass batt insulation previously used on the heater.
