Steam Pipe – Paper Company Personnel Protection & CUI Prevention

Client Name and Location: Withheld, Alabama USA

Application: Steam Pipe

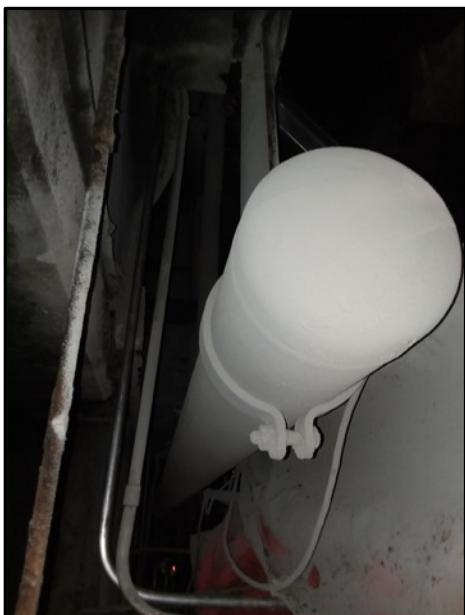
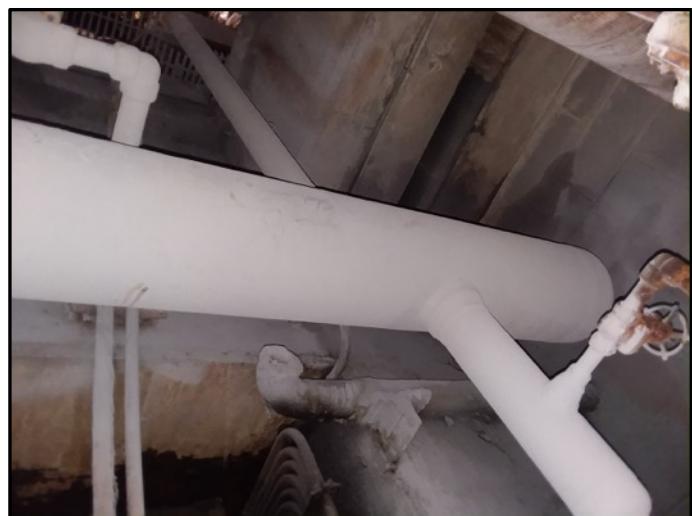
Application Notes: The paper mill had a steam line that was running directly below the 2nd floor. Since a paper mill is an extremely humid and wet environment, moisture would constantly seep into the conventional insulation surrounding the pipe. This moisture would not only cause CUI, but eventually led to the insulation failing and falling off multiple times. After repairing the insulation countless times, the head engineer consulted Mascoat to ask if there was a coating that could replace it. MI-DTI, the company's flagship product, is only capable of sustained loads of 350°F (177°C) with spikes up to 375°F (190°C). At the time, Mascoat's Research and Development Department was working on an insulating coating that would handle higher temperatures, but the Beta Product had only been proven in laboratory scenarios. To observe the coating's abilities in the real world, Mascoat asked if the mill was willing to test the new MI-HT. Since there were no other solutions available to their problem, they gladly agreed.

After application was completed and the pipe brought back into full service, there was no browning, cracking, or debonding of the coating noted over a period of a few days. Any one of these would have been seen as a coating failure. Measurements were taken to verify that the surface temperature was around 130°F, and the Mascoat rep then put his hand on the pipe for 5 seconds to show that it was indeed safe for personnel to touch. The mill and Mascoat deemed the application a success and were anxious to see how MI-HT stood up to the test of time.

Per application instructions, MI-HT was installed on top of a temperature-appropriate primer in a series of 4 coats while the pipe was out of service. After application, steam was gradually released into the pipe to cure the coating at 200°F (93°C). Curing took approximately 2-4 hours, at which time MI-DTI was applied to a thickness of 120 mils in 6 coats. The application took 6 days in total to allow for drying between coats.

Mascoat reached out to the mill once again to see how the coatings were holding up. The report back was succinct and to the point. "The coatings are behaving in the same way as just after they were installed. We have had no maintenance or personnel burn issues, and we're extremely happy with the performance."
