## Storage Tank – Valero

**Company Name:** Valero, St. Charles

**Coating used:** Mascoat Industrial-DTI

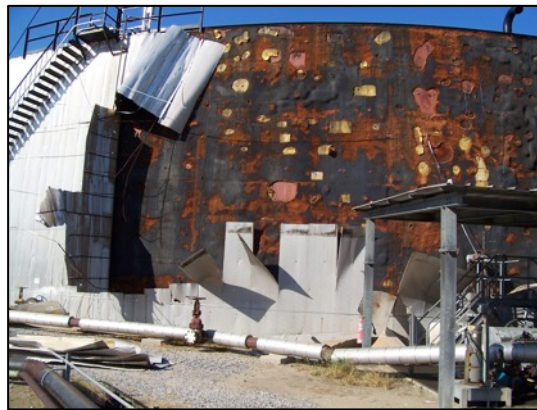
When Hurricanes Katrina and Rita came storming through Louisiana, insulation used in industrial environments was stripped from the sides of storage tanks across the state. Valero had a particularly dangerous situation because when the insulation was ripped off, the Corrosion Under Insulation (CUI) was so severe that the walls of the tank were in danger of failing. Valero knew that they had a big problem even before the storm because when an inspector drilled into the sidewall and the drill punched all the way through the tank wall with little effort. Valero management knew that there had to be a better solution and they consulted with a B&H Distributors of Baton Rouge, LA for the solution to solve their CUI problem when using insulation.
