Sulfur Tank Roof Energy Retention & Personnel Protection

Coating Used: Mascoat Industrial-DTI

Application: Sulfur Tank

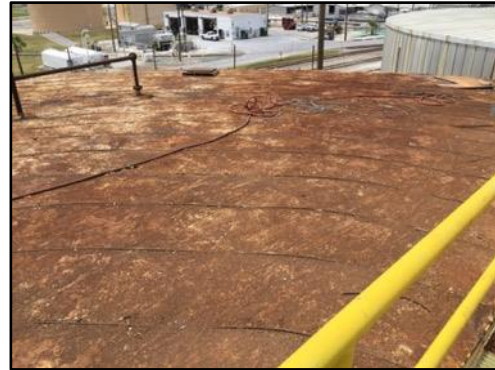
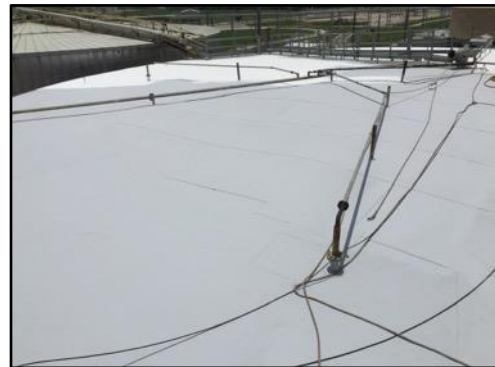
Application Notes: The tank roof had previously been insulated with mineral wool but that had two major drawbacks. The tank roof could not be inspected because walking on the insulation and jacketing would damage the system, and CUI had been able to propagate since they had not been able to inspect the substrate. It was determined that the tank had to be insulated to retain energy, but they needed another type of insulation that did not have these disadvantages. Upon learning about Mascoat's ability to insulate without the risk of CUI and that it could be walked on, the facility asked for a Thermal Analysis Report to predict the heat loss after application. The TAR accurately predicted that the coating would reduce energy needs by 40% versus no insulation and the coating would allow personnel to access without risk of burns or damage to the coating. After application of 120 mils in 6 coats, the client reported that the tank was in good working order and they were extremely happy with the results.

On a follow up visit approximately a year after application, the client reported that there had been an interior fire in the tank. They were pleasantly surprised that there was no damage to MI-DTI, so they did not have to do any repairs to the coating. As a result of the numerous successes, 2 additional tanks have been completed since the original application in 2015.
