## **Case Study**

# **15+ Years of Acrylic Thermal Insulating Coatings**

To effectively showcase the long life cycle of acrylic insulating coatings, Mascoat visited one of its oldest clients in the summer of 2014. This sugar mill is located 12 miles from the Louisiana Gulf Coast and has been using insulating coatings since the mid 1990's.

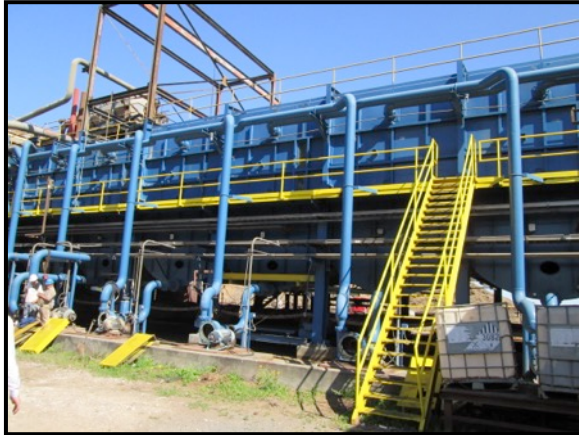
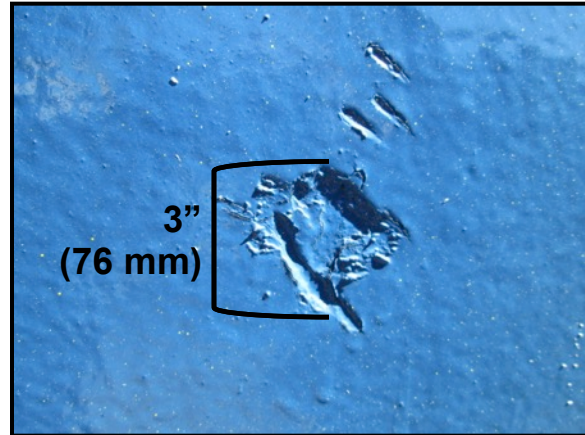
## Diffuser

16+ years service

This diffuser was coated with Mascoat Industrial-DTI and finished with a protective topcoat. It has been exposed to the humid Gulf Coast environment and at least 9 tropical storm or hurricanes since being coated. The plant manager noted that they have no problems whatsoever with corrosion and have had to perform very little maintenance.

To date, the only maintenance needed has been on areas damaged by personnel or flying debris during storms. In those cases, repairs were localized at the point of impact, as shown in the picture to the right. These repairs were completed with Mascoat's Small Application Sprayer using a portable air compressor.

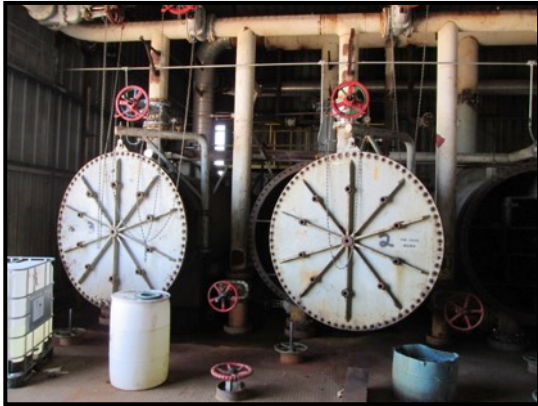
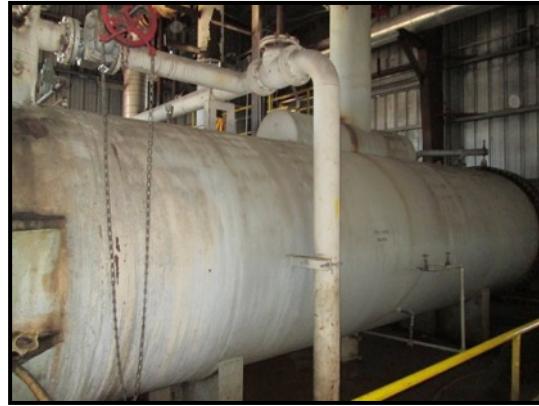
## Evaporators

18+ years service

The evaporator on the right was coated with 80-100 mils (2.0-2.5 mm) of Mascoat Industrial-DTI, while 2.5-3 inches (63-76 mm) of mineral wool was installed on the one on the left. The facility did this to test the performance of the coating versus the mineral wool. When the plant is running, they operate between 212°-215°F (100°-102°C). During trial periods, no discernable difference in energy use was noted.

In the early 2000's, a fire started from a welding job nearby and the mineral wool caught fire very quickly due to molasses leaking into the insulation. After the site was cleaned up, they applied an insulating coating to that evaporator to reduce future fire risk.

Neither evaporator has needed any insulation maintenance since that time. Unlike conventional insulation, molasses is easy to clean up when it leaks on to the coating.

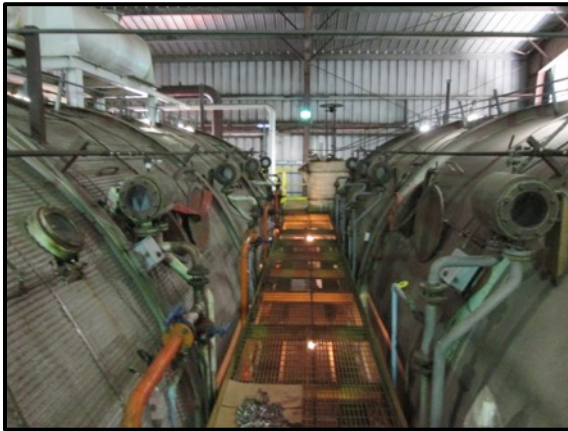
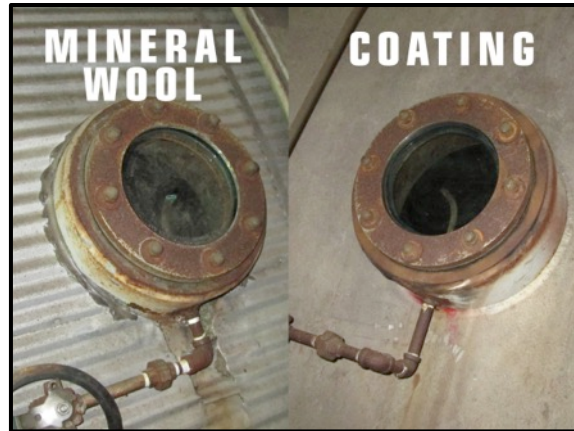
## Reheaters

12+ years service

These reheaters were subject to a similar test like the evaporators above. The one on the left has 2.5" (63 mm) of mineral wool and the one on the right has approximately 120 mils (3 mm) of Mascoat Industrial-DTI. No discernable difference has been noted in the performance, but the plant manager said that they have to perform regular maintenance on the conventional insulation. They have had to do very little to the one with the insulating coating.

The portholes pictured at right go down both sides of both reheaters. The seal on the conventional insulation has been problematic for the company because of the fabrication that is necessary during installation and maintenance. It is also vulnerable to leaks, which allows moisture to enter the system. The plant manager noted that it takes much longer to insulate a reheat conventionally because of the complex geometry. On the other hand, the coating is extremely easy to work around parts that don't need insulation. The applicator simply has to mask those areas off. Once it has been applied, no maintenance has been needed.

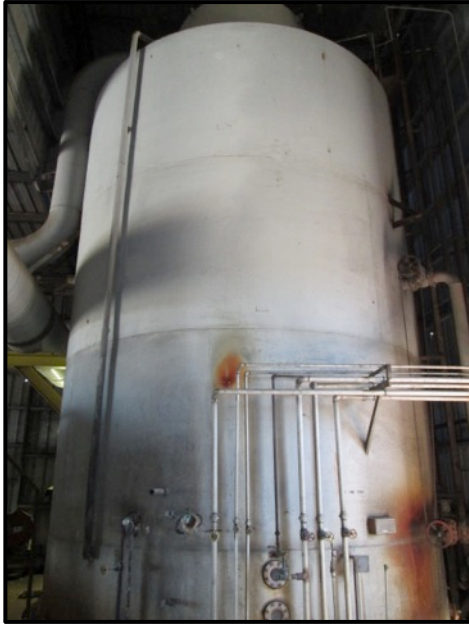
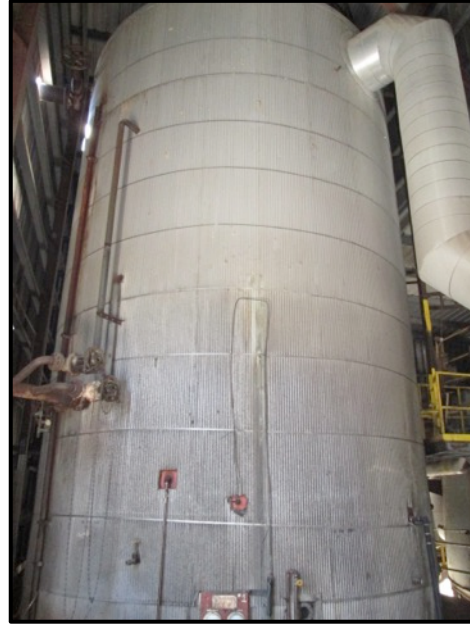
## Clarifiers

15+ years service

These clarifiers are used to separate mud (soil and plant residue) from the raw juice. As with the other processes in the facility, the operating temperature is 190-195°F (87-91°C). In addition to similar ranges of operating temperatures, the facility also saw a benefit in using a thermal insulation coating instead of conventional insulation. With little change in performance, faster installation, and reduced risk of corrosion, future clarifiers will all be coated with Mascoat Industrial-DTI, as it has proven to withstand the test of time in this environment.

Typical conventional insulation thickness before using Mascoat Industrial-DTI was 1.5-2" (38-50 mm). As with the evaporators, using a thermal insulating coating instead of conventional insulation significantly reduces the risk of fire.

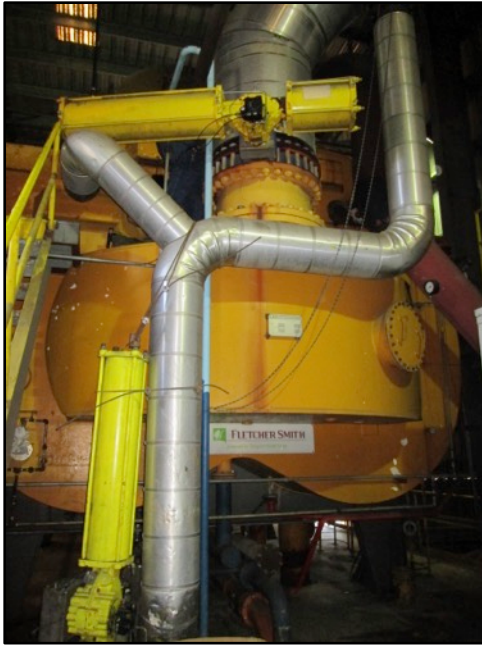
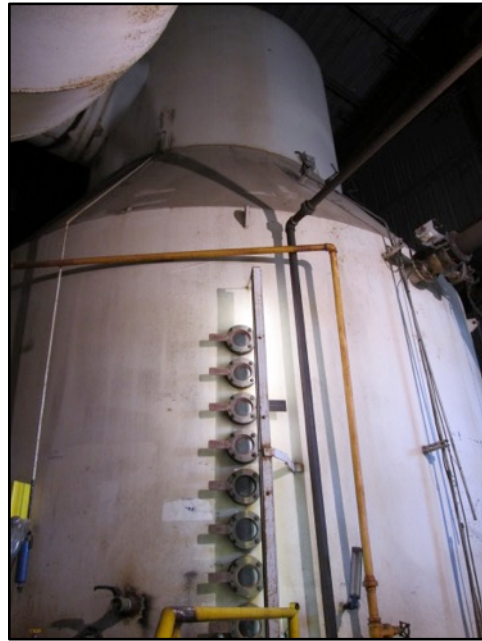
## Continuous and Batch Vacuum Pans (11-18+ years service)

The vacuum pans are on the lower end of the temperature range found in this sugar mill. Operating at temperatures between 165–170°F (73–77°C), the sugar boils and results in crystallization. As you can see in the pictures above, these indoor pieces of equipment consist of very complex geometry that are very difficult to conventionally insulate. Along with the labor involved, there are many areas where moisture can intrude and promote CUI (flanges, inspection ports, support beams, etc.)

Similar to other pieces of equipment, a protective topcoat was applied after the Mascoat Industrial-DTI had fully cured. Because the primary concern is energy retention, a protective topcoat does not have a significant effect on the thermal insulating coating's performance value.
