Oil Refinery Tank Roof

Location: Bayway, NJ

Coating: Mascoat Industrial-DTI

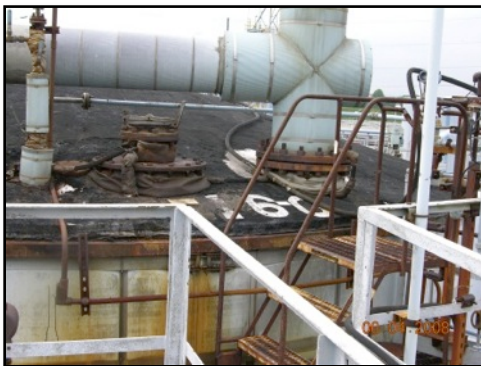
Before

After meetings with the plant reliability managers regarding CUI, it was decided that the facility needed to do something to address the corrosion that many of their tanks tops were experiencing.

Many of these tanks were running hot, above 140°F (60°C), so they needed to be insulated to both save energy, and make sure any personnel working on the vessels would not get burned. However, all of the other methods to insulate and/or protect the tanks never prevented corrosion, which leads to shortened tank life spans or increased maintenance needs.

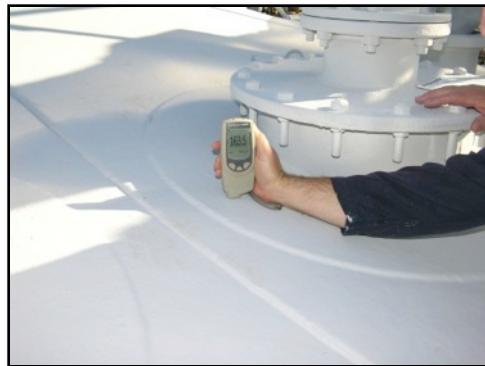
After – Tank 160 with 160 mils (4 mm) of Mascoat Industrial-DTI

They decided to use Mascoat Industrial–DTI on one tank top to see if it worked as a solution for their problem. In July 2010, West Virginia Paint, an onsite painting contractor quickly installed 160 mils (4 mm) of the coating on Tank #160. There was also a topcoat applied to insure proper chemical resistance. Since installation, they haven't had any issues with corrosion or personnel injury on that tank.
