Shelter from the Next Storm: Damaged Insulation Replaced with Coating that Insulates

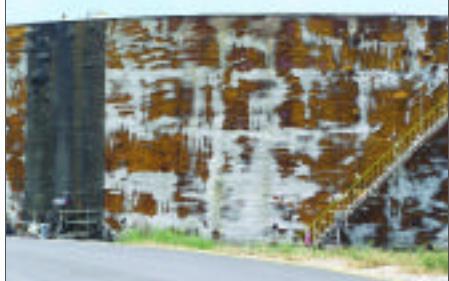
Hurricane damage on tank Photos coutesy of Valero

shortly thereafter. After Hurricanes Katrina and Rita dam-

aged the insulating systems on several storage tanks in the

autumn of 2005, the company under-

took the coating of three carbon steel storage tanks as part of its maintenance program, says Darrel Plants of Valero.

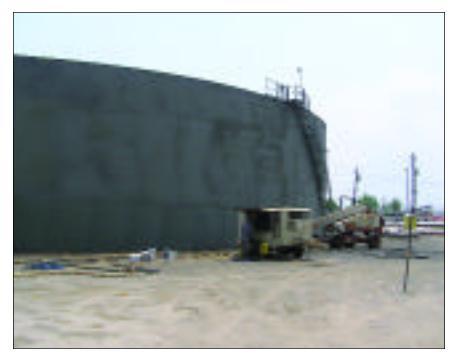
One of the tanks after priming

White) finish with a profile of 2 to 2.5 mils (50 to 62.5 microns), says John Seguin, the contractor's site manager. Using airless spray, the contractor then applied an inorganic zinc primer to a dry film thickness (dft) of 2.5 to 3 mils (62.5 to 75 microns). Two coats of the insulative coating spray were applied next to a dft of 20 mils (500 microns) per coat to assure thermal protection. The contractor notes that the water-borne acrylic coating is user friendly and has no recoat or overcoat requirements, an important consideration in the humid climate of Louisiana. In addition, says Seguin, overspray was not a concern because the dry fall range of the insulative coating is relatively narrow at 3 to 5 ft (0.9 to 1.5 m),

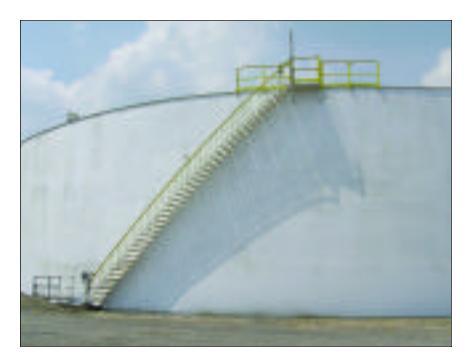
Finished tank

Following a presentation by the coating manufacturer's representative, Valero chose a water-borne acrylic coating containing hollow ceramic particles to protect the tanks. The insulative coating can protect surfaces up to 400 F (204 C), with peak loads to 500 F (260 C), the manufacturer says.

In all, 126,000 sq ft (11,340 sq m) of carbon steel had to be coated, says Plants. At press time, the painting of the third tank was underway, with completion expected by the end of June. "We're very satisfied with what we got out of the product. It's maintaining product at the proper temperature," he says. When Valero's painting season begins next year, it will use the insulative coating on other storage tanks. "We can eliminate the problem of corrosion under insulation with this spray-on coating," says Seguin.
