Rope company has a handle on abrasion

Maritime ropes supplier, Lankhorst Ropes has developed an innovative, abrasion resistant coating for its Lankoforce ropes, with the goal to simultaneously improve abrasion resistance and make the rope easier to handle.

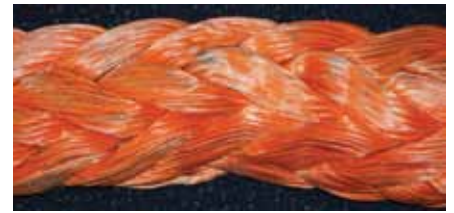
▲ Lankoforce Challenger rope coating.

The Lankhorst-developed Challenger rope coating is designed to replace the Lankoforce's protective jacket along the body of the rope, while retaining a jacket for the high-wear, splice eye.

The low-friction coating is applied to the rope during production and has been shown in trials to significantly reduce the effects of abrasion. Moreover, the absence of the jacket means the Lankoforce rope requires less maintenance, is simpler to inspect, and even easier to handle.
