The Beet Goes On! Tank Insulation Coating

BY JACK INNIS, CONTRIBUTING EDITOR

Spray apply composite ceramic- and silica-based insulating coating to the exterior of nine tanks at a Nebraska sugar beet processing facility

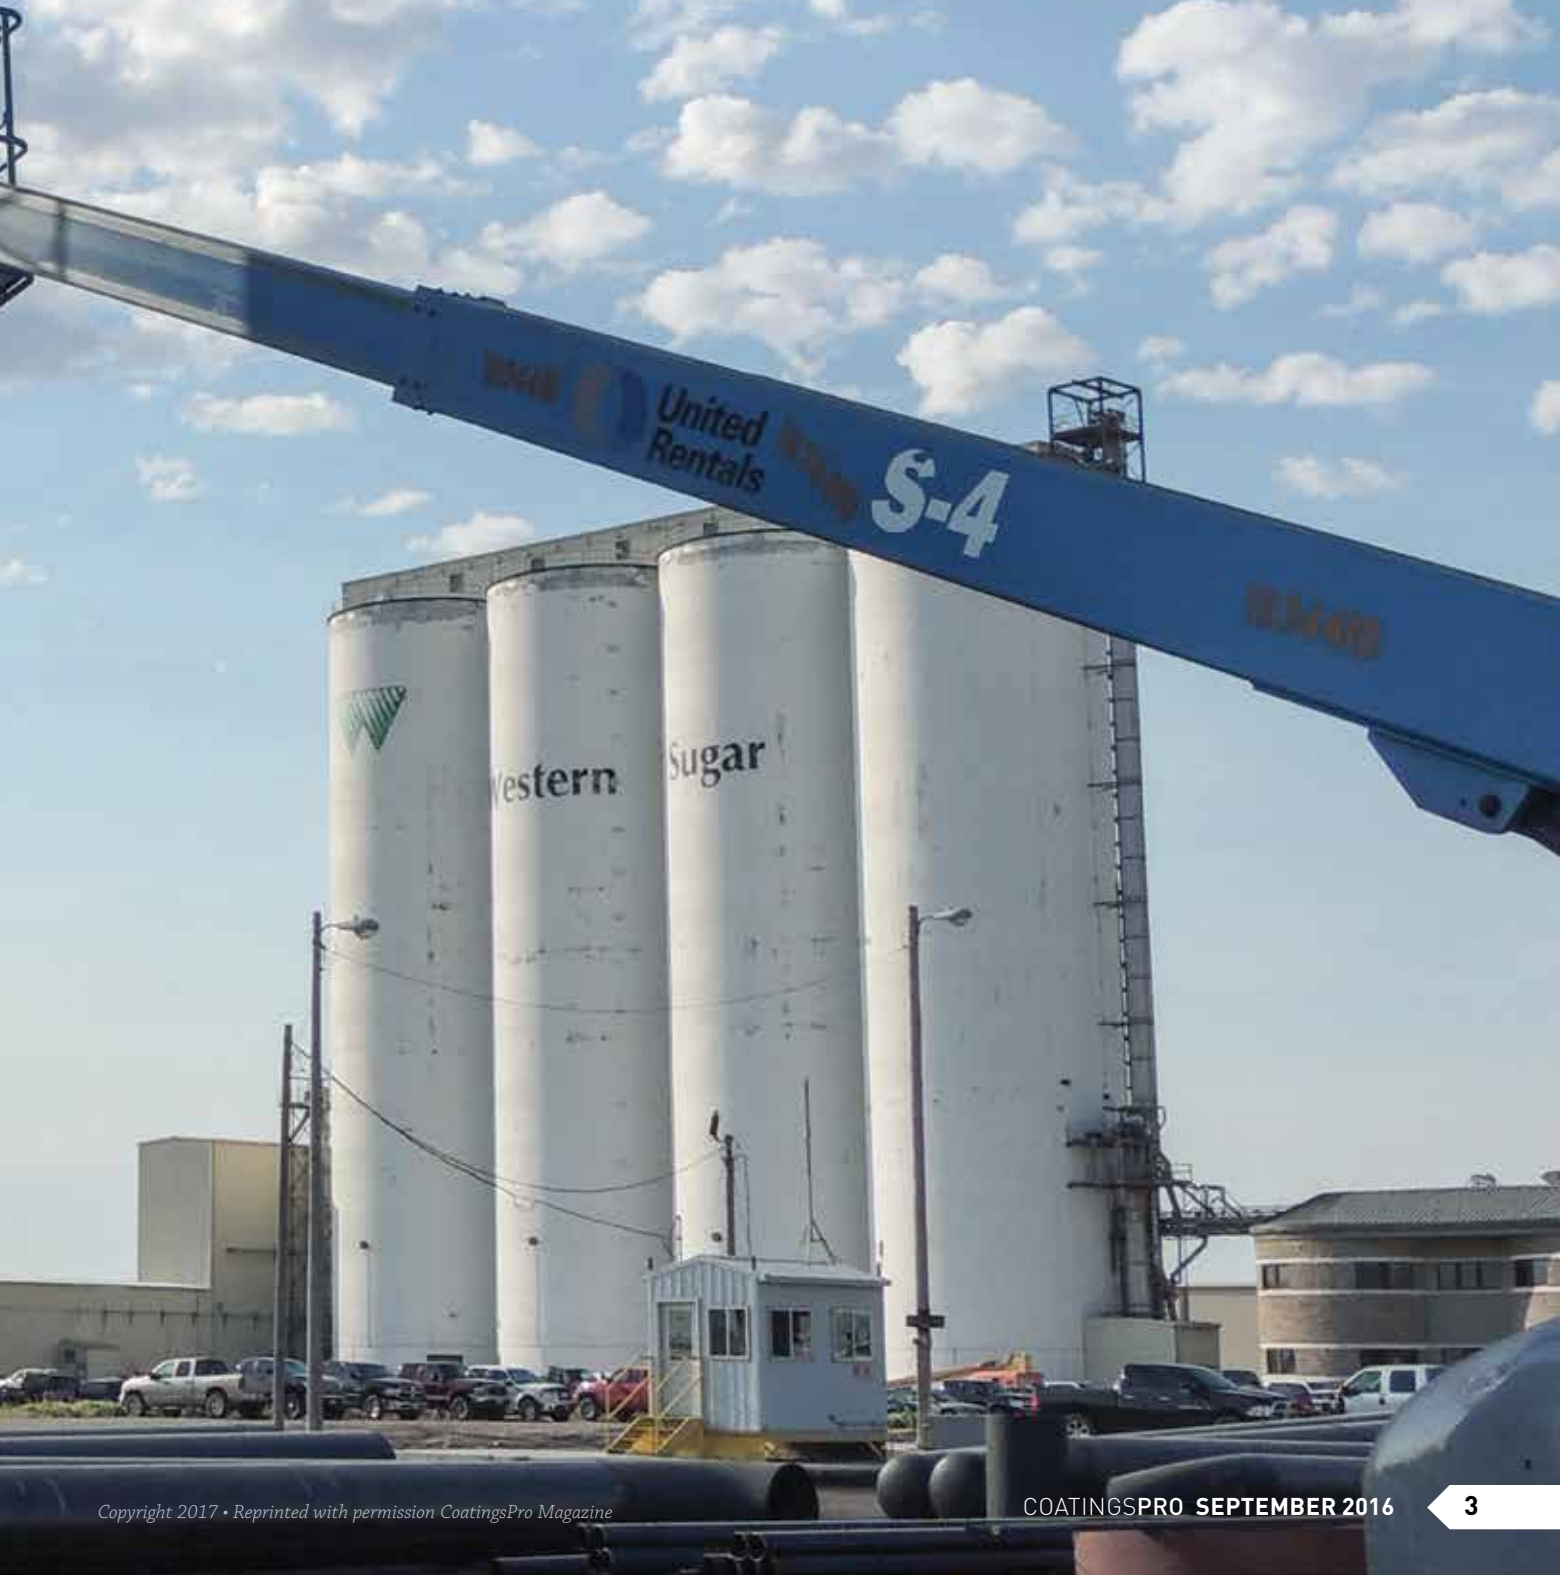
WSC recently decided to increase capacity at Scottsbluff by adding nine new steel processing tanks. After careful deliberation, the co-op opted to kick the fiberglass habit.

WSC recently decided to increase capacity at Scottsbluff by adding nine new steel processing tanks. After careful deliberation, the co-op opted to kick the fiberglass habit. This time around, they'd beat the heat with Mascoat Industrial-DTI, a composite ceramic- and silica-based coating designed to insulate and block corrosion.

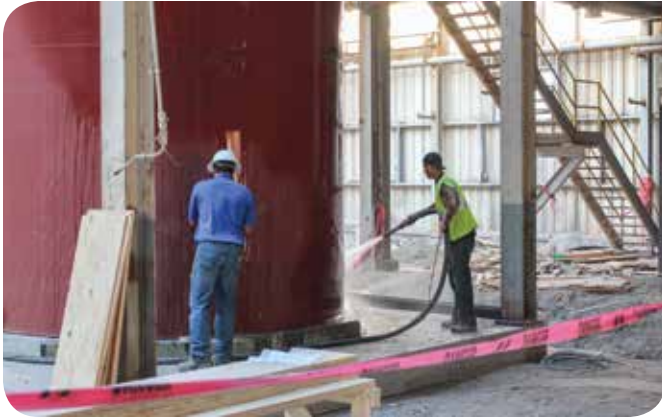
For Eric Reichert Insulation & Construction, Inc. (ERIC), the coating of nine tanks for a beet sugar processing facility was sweet! To start, the crew blasted the tanks using a Graco EcoQuip and HOLD*BLAST.

The crew’s first task was to remove mill scale and surface rust by abrasive blasting tank exteriors. Specs called for NACE No. 3/Society for Protective Coatings (SSPC) Surface Preparation (SP) 6: Commercial Blast Cleaning, so the crew members busted out Graco EcoQuip vapor blasters. The EcoQuip vapor blaster eliminates more than 90 percent of airborne dust while using less water than wet or slurry technologies, according to manufacturer’s spec sheets. The low-dust blast allowed the crew to forgo

To help beat flash rust, the crew added HOLD*BLAST by CHLOR*RID to the EcoQuip's water tanks at a 50:1 ratio. Running the anti-rust agent through the vapor blasters saved time compared to spraying HOLD*BLAST onto each tank after blasting. It also gave the crew breathing room between the blast and the basecoat application.

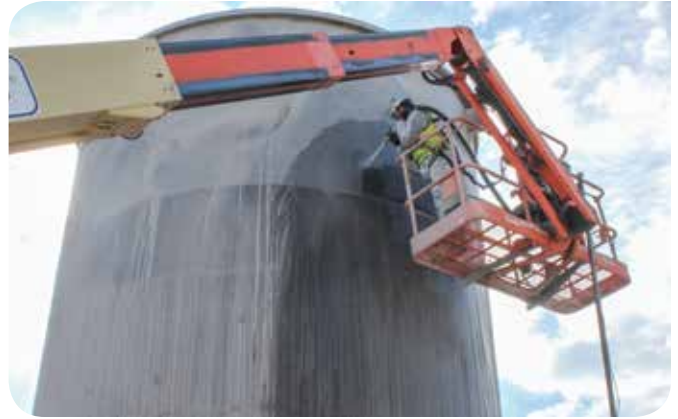
The project crossed eight weeks and ~28,500 square feet (2,647.7 m²) of new carbon steel with mill scale and surface rust. And the project was only two blocks from the crew's shop!

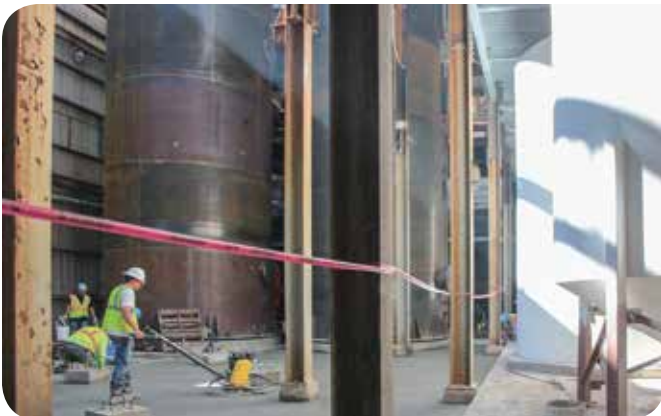
The project had to work around beet harvest, and the crew had to work around safety parameters. They watched for thunderstorms, wore fall protection, and any personal protective equipment (PPE) as required.

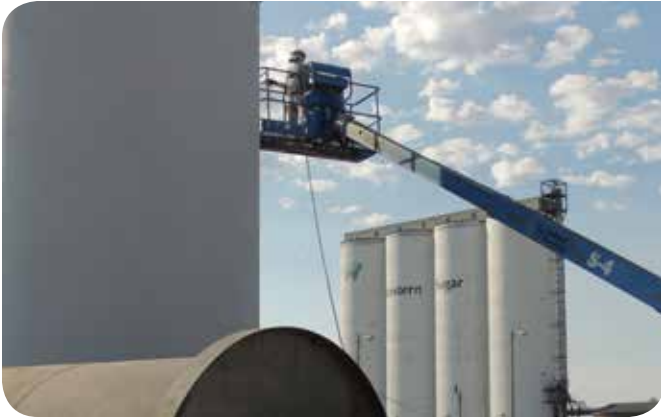
The six-person crew spray applied one coat of International Paint's Intertherm 228 at 4–6 mils (101.6–152.4 microns) dry film thickness (DFT). Both this primer and the DTI were applied in a crosshatch strategy.

Mascoat's insulating coating self-primes over non-ferrous metals, such as aluminum and stainless steel, but these carbon steel tanks required International's Intertherm 228 HS basecoat. Intertherm 228 HS is a two-component, high-build epoxy specifically formulated for use beneath thermal insulation coatings (TIC). Working with afternoon air temperatures hovering around 100° F (38° C), 228 HS offered an operational pot life of about an hour, according to Rein, who did much of the spraying. His go-to rig for the 228 HS was a Spray Tech airless with 519 tip.

"We were aiming for 4 to 6 mils [101.6–152.4 microns]," Rein said. To achieve that dry film thickness (DFT), Reins and his crew crosshatched the spray using horizontal and vertical sweeps. "We weren't overly concerned about putting down too much material — 8 mils [203.2 microns] would have been okay — but we definitely didn't want any spots with just 3 mils [76.2 microns]."

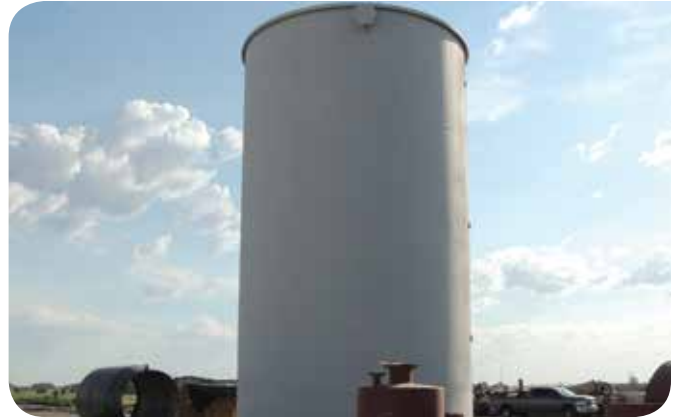
The final step in the system was three to eight coats of Mascoat's Industrial-DTI at 15–20 mils (381.0–508.0 microns) DFT per coat. That couldn't happen when wind exceeded 10 mph (16.1 kph).

Since the tanks hold beet juice at a various temperatures, insulation needs varied. Therefore, the tanks were specified to receive three different total dry film thicknesses of 228 HS: approximately 60 mils (1,524.0 microns), 90 mils (2,286.0 microns), and 150 mils (3,810 microns). That meant on average between three and eight coats per tank at 15–20 mils (381–508 microns) DFT per coat. That also meant a great deal of time allotted for curing between coats. With no time to lose, the ERIC crew fired up their Graco GH 833 Big Rig sprayer.

"We sprayed the DTI just like the Intertherm, crosshatching, but unlike the primer where we didn't mind going a bit heavy, we didn't want to put down too much DTI," said Rein. "Any single coat over 30 mils [762.0 microns], we felt there might be a risk of trapping moisture inside and not getting a full cure."
