# A BETTER INSULATION SOLUTION FOR FLOOD PRONE AREAS

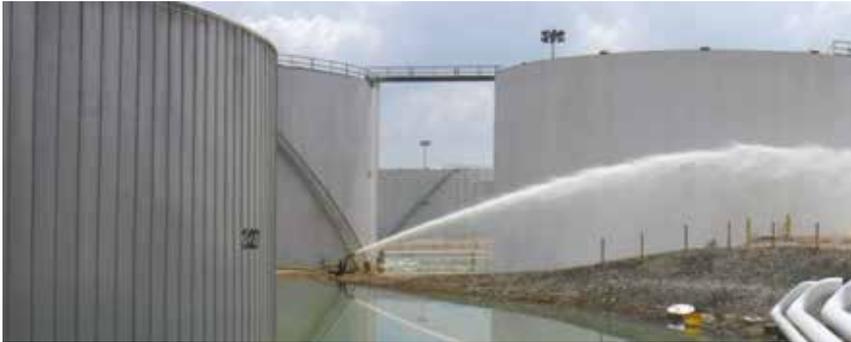
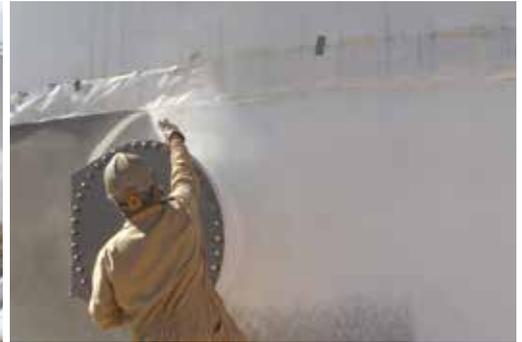
One company in the rainy Pacific Northwest (US) had issues with CUI due to moisture intrusion at the area just above the chime. By installing DTI to the bottom 2 feet of the tank and specially fabricating the insulation jacketing immediately above it, the company was able prevent future issues with moisture entering the insulation and causing

constant maintenance worries. In fact, the maintenance supervisor said, "I thought this was a pretty slick system for addressing the issue of under insulation corrosion damage. In the past, I've used a coating system suitable for under insulation service. But this way, you still have a visual on the chime and you don't have to strip off insulation to perform an inspection."
