## Cargo Vessel – El Yunke

**Vessel:** Cargo Vessel El Yunke

**Coating used:** Primer unknown, Mascoat Marine-DTM at 60 mils (1.5 mm)

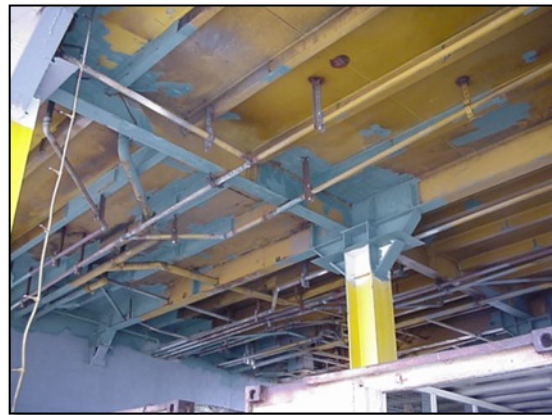
The cargo vessel El Yunke had a major problem during transport. The lower deck level insulation and jacketing system had deteriorated beyond its ability to provide insulation, as well as being a tremendous safety hazard in the overhead. Also, heat from the lower decks of the ship would cause condensation on the second deck, resulting in hazardous working conditions for the personnel working in the area.
