Lemon Juice Drums

Coating used: Mascoat Industrial-DTI

Reason for application: Personnel protection & energy retention

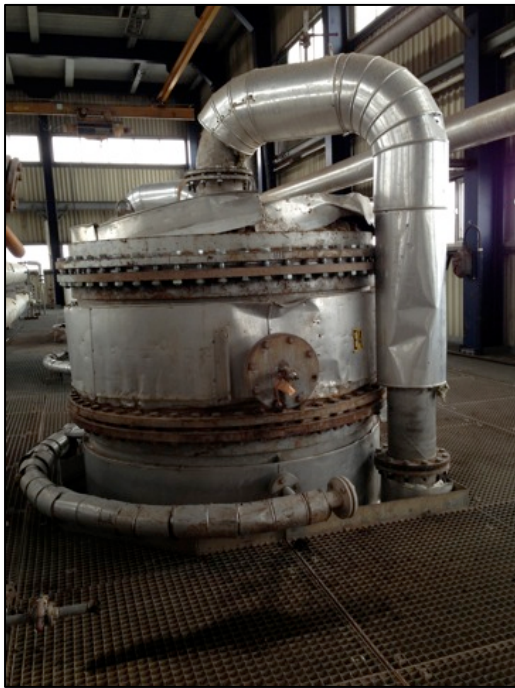
Before

In these 30 M high drums they ensure that all residue is evaporated and clear product remains. The residue is shipped to a different part of the plant where they use it to make secondary products. The covers and drums need to be cleaned and serviced after each cycle. They lift the covers with a forklift and due to this reason the damaged the traditional insulation all the time as you see in the top left picture. The damaged insulation was often only partly replaced leaving bare stainless metal, which caused hazards to personnel and significant energy loss. When this company turned to Mascoat for advice they provided them with a solid solution for both of their problems. With only 120 mils (3 mm) DFT Mascoat Industrial-DTI layer we were able to reduce the surface temperature to an acceptable level and provided a seamless insulation cover.
