Petroleum Storage Tanks

Company Name: Kinder Morgan

Location: Staten Island, NY USA

Coating: Mascoat Industrial-DTI

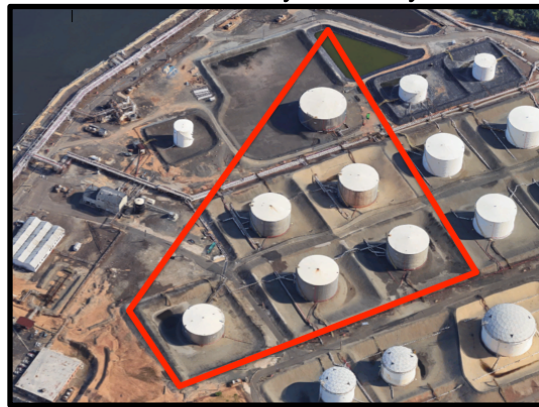
In 2009, Kinder Morgan had a problem at their Staten Island facility that they could not solve. They were going through a great deal of energy to keep product at temperature but didn't feel that they could insulate due to the risk of Corrosion Under Insulation and weatherability. The weather on Staten Island is consistently windy and rainy. Conventional insulation had been ripped off from the wind in the past and they had many problems with CUI when the insulation stayed in place. They felt that they had no option until they discovered Mascoat and its thermal insulating coating, Mascoat Industrial-DTI.

Because it bonds directly to the substrate, wind cannot rip the coating off and moisture cannot penetrate between the coating and substrate. A Thermal Assessment was performed to show the difference between an uninsulated tank and one coated with Mascoat Industrial-DTI. The report showed that the coating would provide approximately 10% in energy savings. Kinder Morgan's engineers agreed with the assessment and application commenced on the roof of 6 tanks in August of 2009. After the coating was installed, they expressed their satisfaction with the product, particularly because of the energy savings they couldn't achieve prior.

One of the main reason many tank roofs go uninsulated is because personnel cannot access the roof when conventional insulation is used. The client was happy because the roof could be insulated using Mascoat Industrial-DTI while still being accessible to personnel with no fear of damaging the insulation.

2017 Update: During a 2017 visit to the storage facility by a Mascoat representative, the Operations Manager, Mike McEvoy, reported that the 6 tanks coated in 2009 are still performing exactly as they were in 2009. The coating also survived SuperStorm Sandy in 2012 without damage, and no CUI has been reported to date. In fact, he is astounded that the tanks look like new, even 8 years after the coating was installed.
