Depropanizer and Deisobutanizer

Coating: Mascoat Industrial-DTI

Reason for application: Corrosion Under Insulation (CUI)

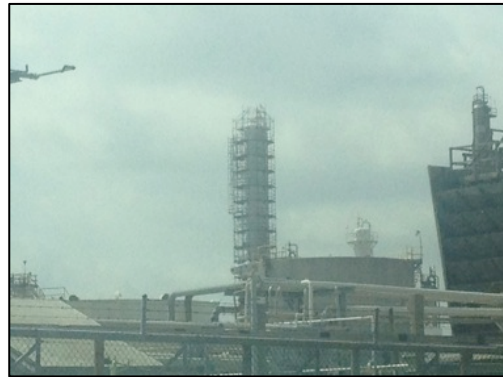
Depropanizer Tower

- Height – 95'
- Diameter – 6.5'
- Surface temperature – 130°F (54.4°C)
- DTI thickness – 60 mils (1.5 mm)

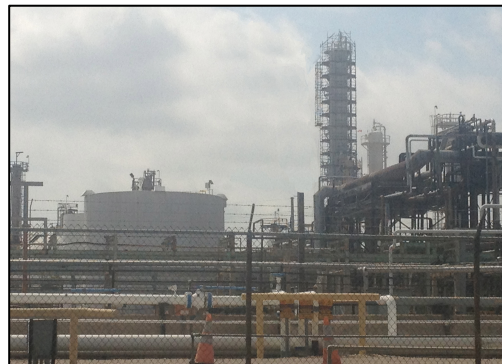
Deisobutanizer Tower

- Height – 114'
- Diameter – 8'
- Surface temperature – 185°F (85°C)
- DTI thickness – 80 mils (2 mm)
